CoT Handbook 2.0 2023 - PAINT

1 Paint on historic vehicles

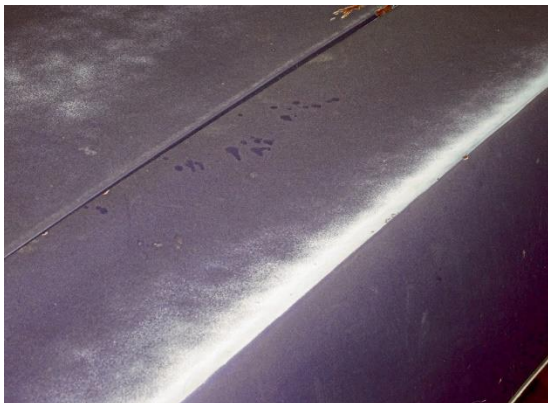
Faded and weathered metallic paint on a Dodge Superbee, model year 1970 – supposedly the original coating. It is not possible to repair the paintwork in a way that imitates this visual effect. The violet metallic paint is virtually completely destroyed.

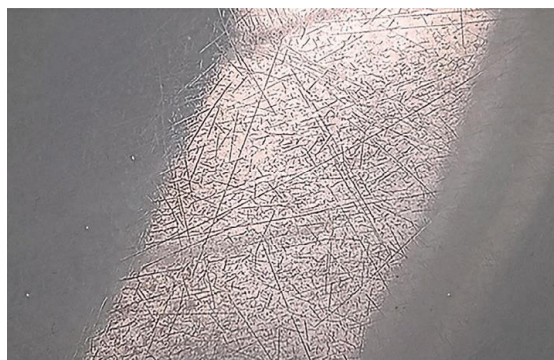
Cracked paint on a Panhard Dyna X, model year 1949 – probably the original coating. The paintwork still has a protective effect. The cultural aspect takes precedence over the need to repair this surface. If stored or conserved

*properly,
this vehicle can still enjoy a long life.*

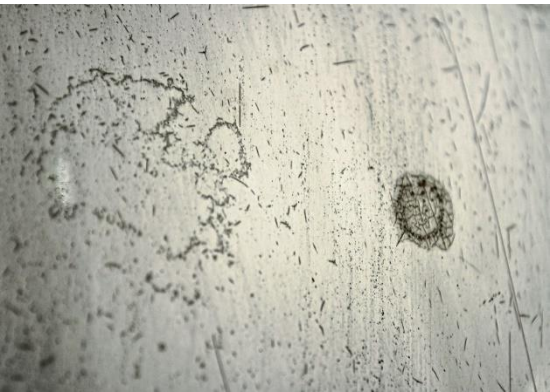
Paint on a Porsche 911 from the south-west of the U.S. The surface damage is easily highlighted using black control powder. In some areas, the paint is cracked and has been destroyed by sunlight and acid, and possibly also by insects and bird droppings. The technical and traditional approach would be to rub down the surface and repaint it. The cultural preservation approach would be to conserve it and retain the existing surface for as long as possible. The final decision will be made by the vehicle owner and the technical testing authority

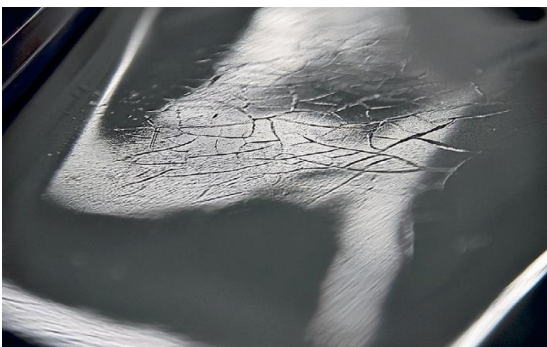
Recoated cracked old paintwork. This image shows a destroyed layer of paint with no patina.

However, this kind of technical damage may also be worthy of preservation in the eyes of the vehicle owner.

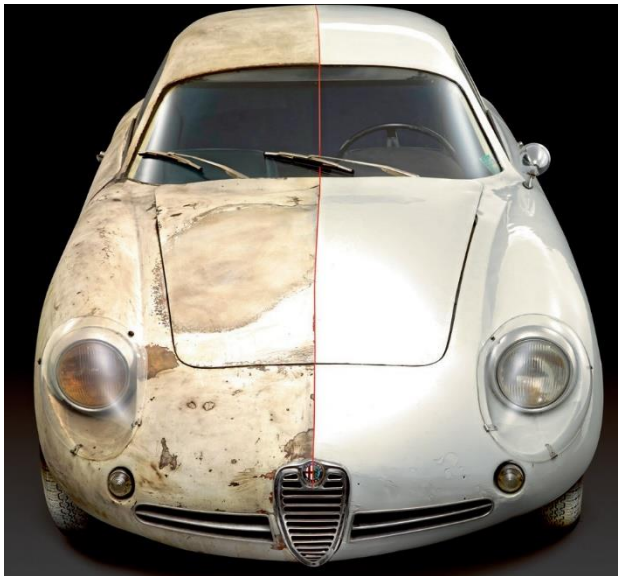
[21]

Half of the Alfa Romeo SZ from Lopresto's collection bears a mixture of aged and original white paint, while the other half is still covered in the years of dirt that have accumulated on the paintwork.

Half of the Alfa Romeo Giulietta SZ prototype from 1961 bears a mixture of aged and original white paint, while the other half is still covered in the years of dirt that have accumulated on the paintwork. The idea was to show the condition in which the car was found and how it can be preserved through conservation.

Work on the coating began on the dirty side of the car, with the fixing of the loose color residues using a special elastic adhesive. This half of the car was then covered with a transparent coat to preserve the condition in which the vehicle was found as effectively as possible.

The other half was carefully cleaned using gentle cleaning products. More stubborn dirt was removed with great care using mechanical methods. Where the paint was missing, the car was retouched with two-component paint in a precisely matched

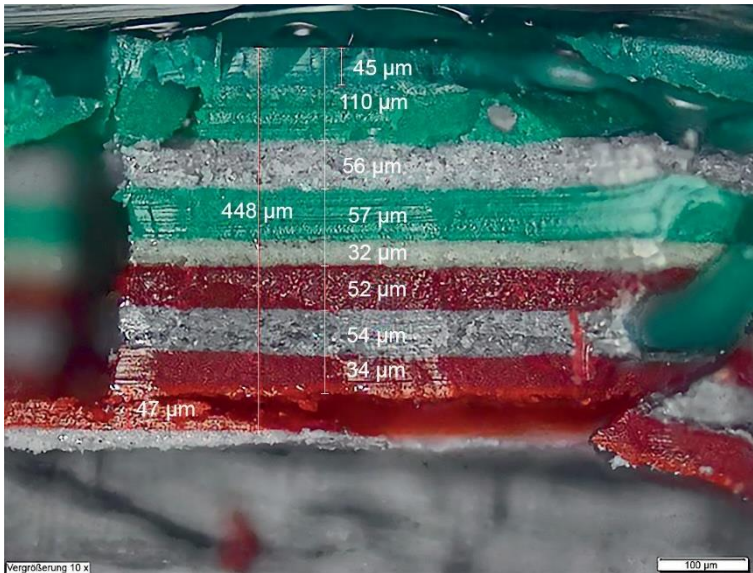
Porsche 356: Image showing cross-section of paint layers under a microscope [20]

There was virtually no patina worthy of keeping and the history of the vehicle was only partially documented up to around 1967. The paint layers are indicators of the vehicle's story: It was painted multiple times, at least twice in red and two or three times in a shade of green. This 356 was clearly never considered a cultural asset and spent its service life in intensive use as an object of utility.

Expanding foam was used in the passenger door for noise insulation and repairs, while rust spots had been smoothed over across large areas.

The 356 was repainted in authentic, high-gloss Ruby Red paint with smooth flow characteristics to mimic the original look. Reutter handed the vehicle over to Porsche polished to a high-gloss shine.

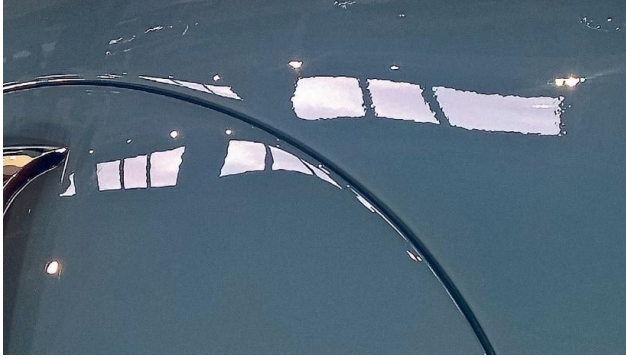
Significant differences in paint flow on the hood and front end of a recently restored Porsche 356

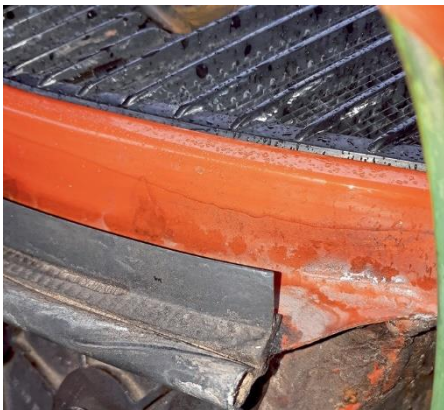
On opening the hood, it becomes clear that the paintwork on this Mercedes-Benz W 123 is not original

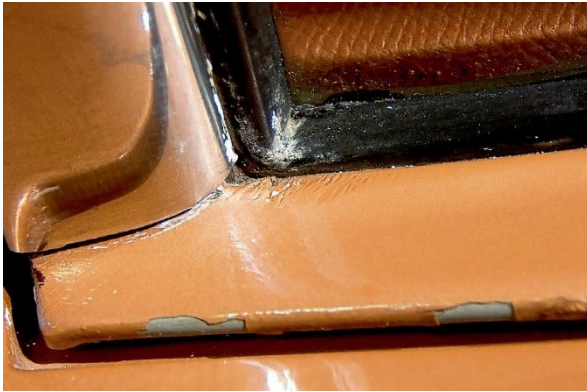
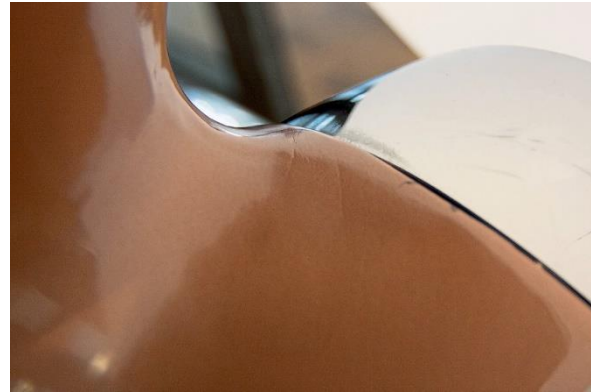
Important to know vehicle-specific details: What may look like paint defects could actually be authentic marks left behind by car body files. Extreme designs, like the jagged bodywork and tail fins seen in 1959, could not be achieved using the metal pressing technology of the era. These components were finished by hand, which left sanding marks behind.

- Are there any areas of unevenness that cannot be attributed to defects during restoration, but that were caused by errors during production, e. g. traces from car body files left during the production of extreme body shapes such as the 1959 Buick LeSabre?

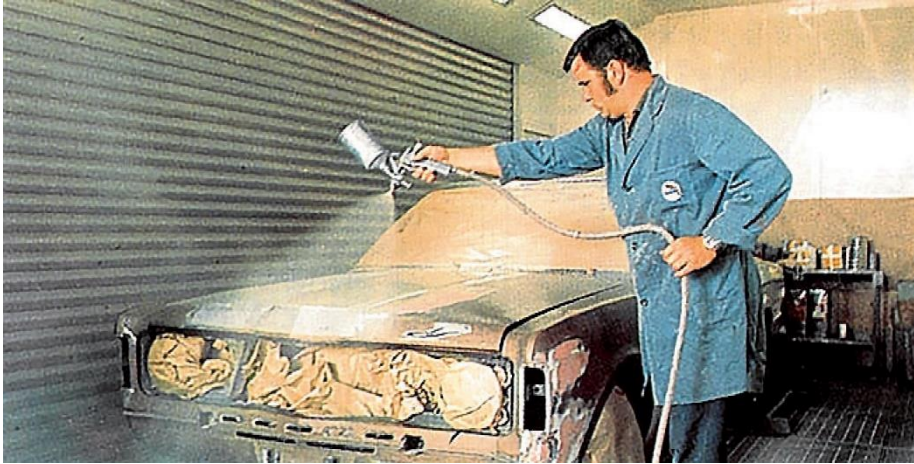
[20]

A professional refinish job on a car body in 1971

The photo below shows a typical refinish job from 1971. The image was captured for the launch of the 21 Line two-component PUR topcoat from Glasurit. The Ford "Knudsen-Taunus" in the photograph has since become a cult classic, but the environment in which it is pictured has seen some fundamental changes. Examples include safety considerations such as personal protective equipment for the spray painter and adequate ventilation in the working area. The spray gun in the image is now something that you would find in a museum and has been replaced by guns that

guarantee optimum atomization and little overspray. The solvents, pigments and other ingredients have also been adapted to comply with current regulations. Raw material changes due to legislation and economic reasons are frequently happening. For this reason, it would not be possible to perform a paint repair using exactly the same historical methods and materials.

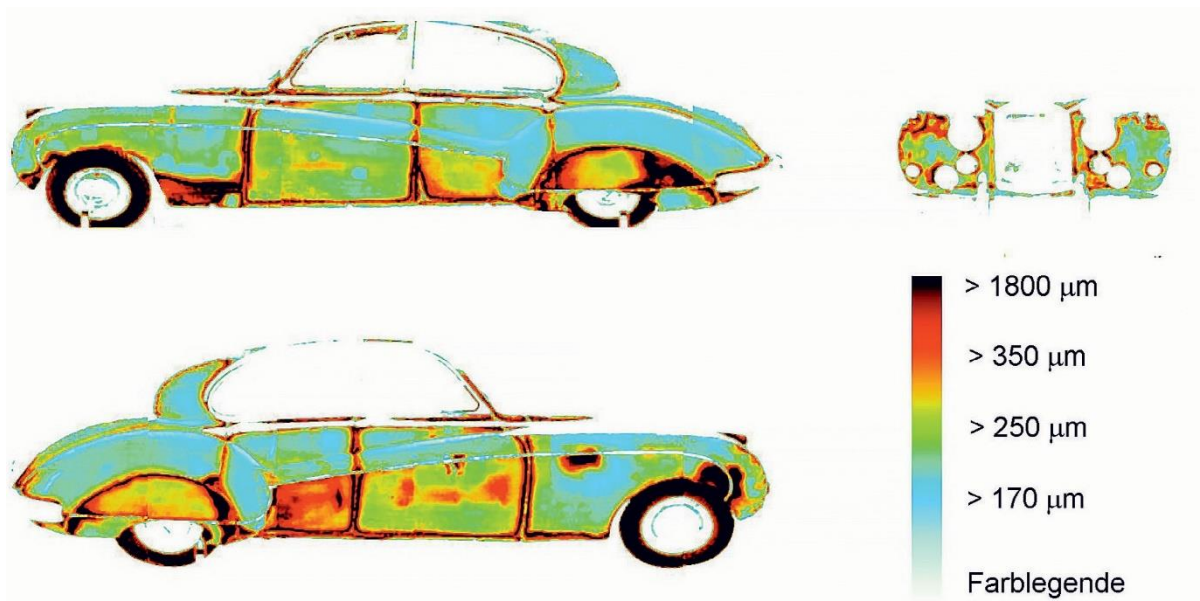
Figure 8.34 A thermographic image of a Jaguar MK IX, model year 1960.

With this in mind, it is essential to use the latest painting technologies and refinishing processes to achieve long-lasting repairs that produce a visually consistent effect. There is no doubt that new technological solutions will play an increasingly important role in the maintenance, repair and restoration processes. It is already possible to use 3D printers to recreate spare parts that are no longer available, and to use modern tire technology in replicas of historical tires. In vehicle evaluation, methods that provide information about the paint history of a classic car – without interfering with it in any way – will become the norm. Examples include thermography inspections (www.classic-car-check.com), which originated in the aerospace industry, and ultrasound testing, which can show all the layers of paint on a vehicle.

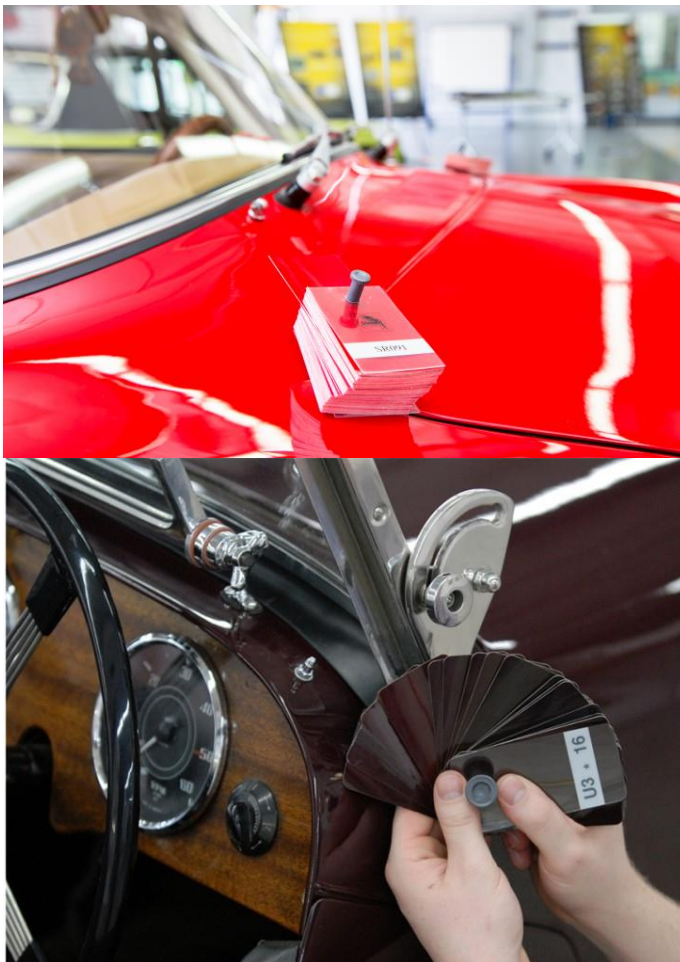
Photos: Glasurit Color Profi System:

Organized reg. colors, not manufacturers and painted with real refinish paint. The high success rate to identify the matching color on the car.

In general, the goal is to retain the intact old paintwork and, in the event of damage, to make an invisible repair where possible. One very important aspect of this is to ensure that the color matches the vehicle and the area being repaired on the vehicle. As described above, this is possible if the color is determined using a spectrophotometer and/or other color information tools. It may also be necessary to tint the color slightly. "Tinting" was a real profession in the old days and is now more and more replaced by Spectrophotometers.

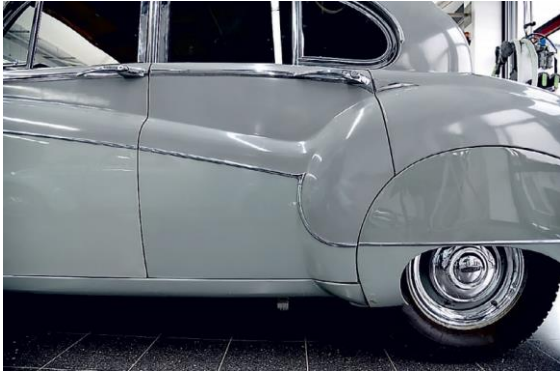
Two-tone paintwork on a 1960 Jaguar MKIX. After several (unknown) paint operations you find ca. 20 different variants across the individual parts of the vehicle.
